# Manhole Inspection Summary

Manhole # S09EE2005MH

Insp Date: **9/18/06 2:37 PM**

**Location** Address: **6201 IVYMOUNT RD**

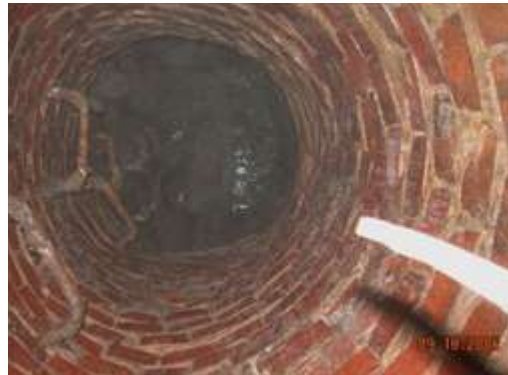
Top View

Count: **10** Missing: **0** ☒ **Corroded**

Corroded steps.

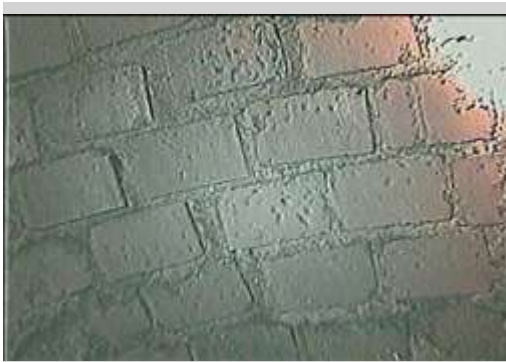
Defect

Infiltration: ☐ None ☒ **Joint** ☐ Cracks ☒ **Mortar** ☐ Roots ☐ Wall

Infiltration: ☐ None ☐ Joint ☐ Cracks ☒ **Mortar** ☐ Roots ☒ **Wall**

Adjustment and Corbel infiltration.

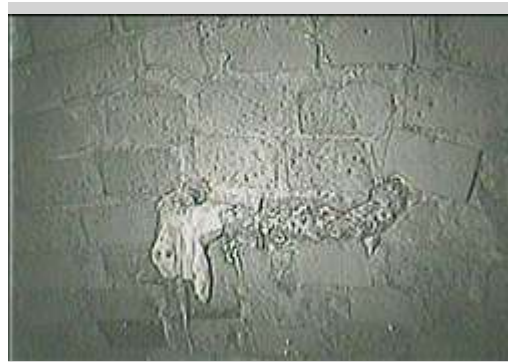
Defect

Evidence of surcharge.

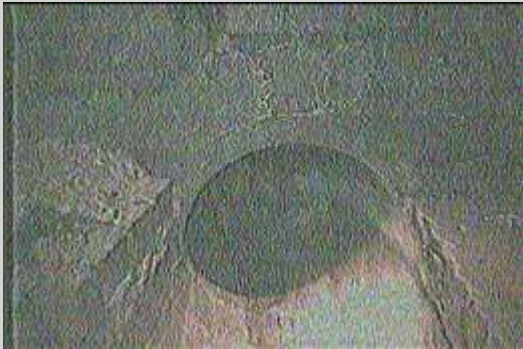
### 15 in. Circular Gravity Sewer Pipe Out @ 12 O'Clock

Condition: ☐ Sound ☐ Cracked ☐ Root Intrusion ☐ Loose Brick ☒ **Deteriorated**

Condition: ☐ Sound ☐ Cracked ☐ Root Intrusion ☒ **Deteriorated** ☐ Leaks ☐ Debris

Barrel deterioration and infiltration. Channel deterioration.

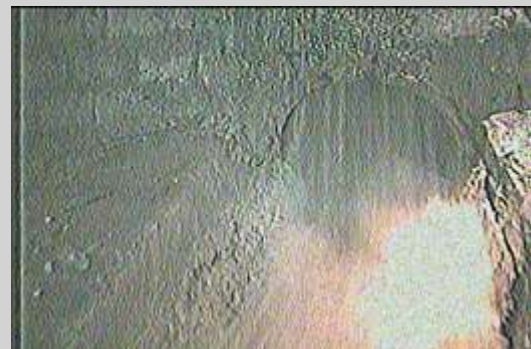
Drop In @ 6 O'Clock

Channel deterioration.

Drop Condition: **Partly Clogged**

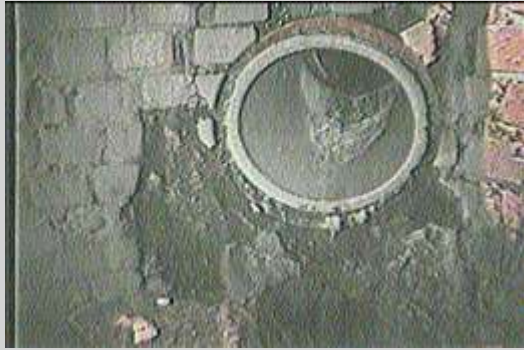
Pipe In @ 8 O'Clock

Barrel deterioration and infiltration.
